California State Board of Equalization
450 N Street, Sacramento, California

Activities on Floors 22 through 24
Revised Report
Project No. 2372.02-572

Report Date:
January 9, 2013

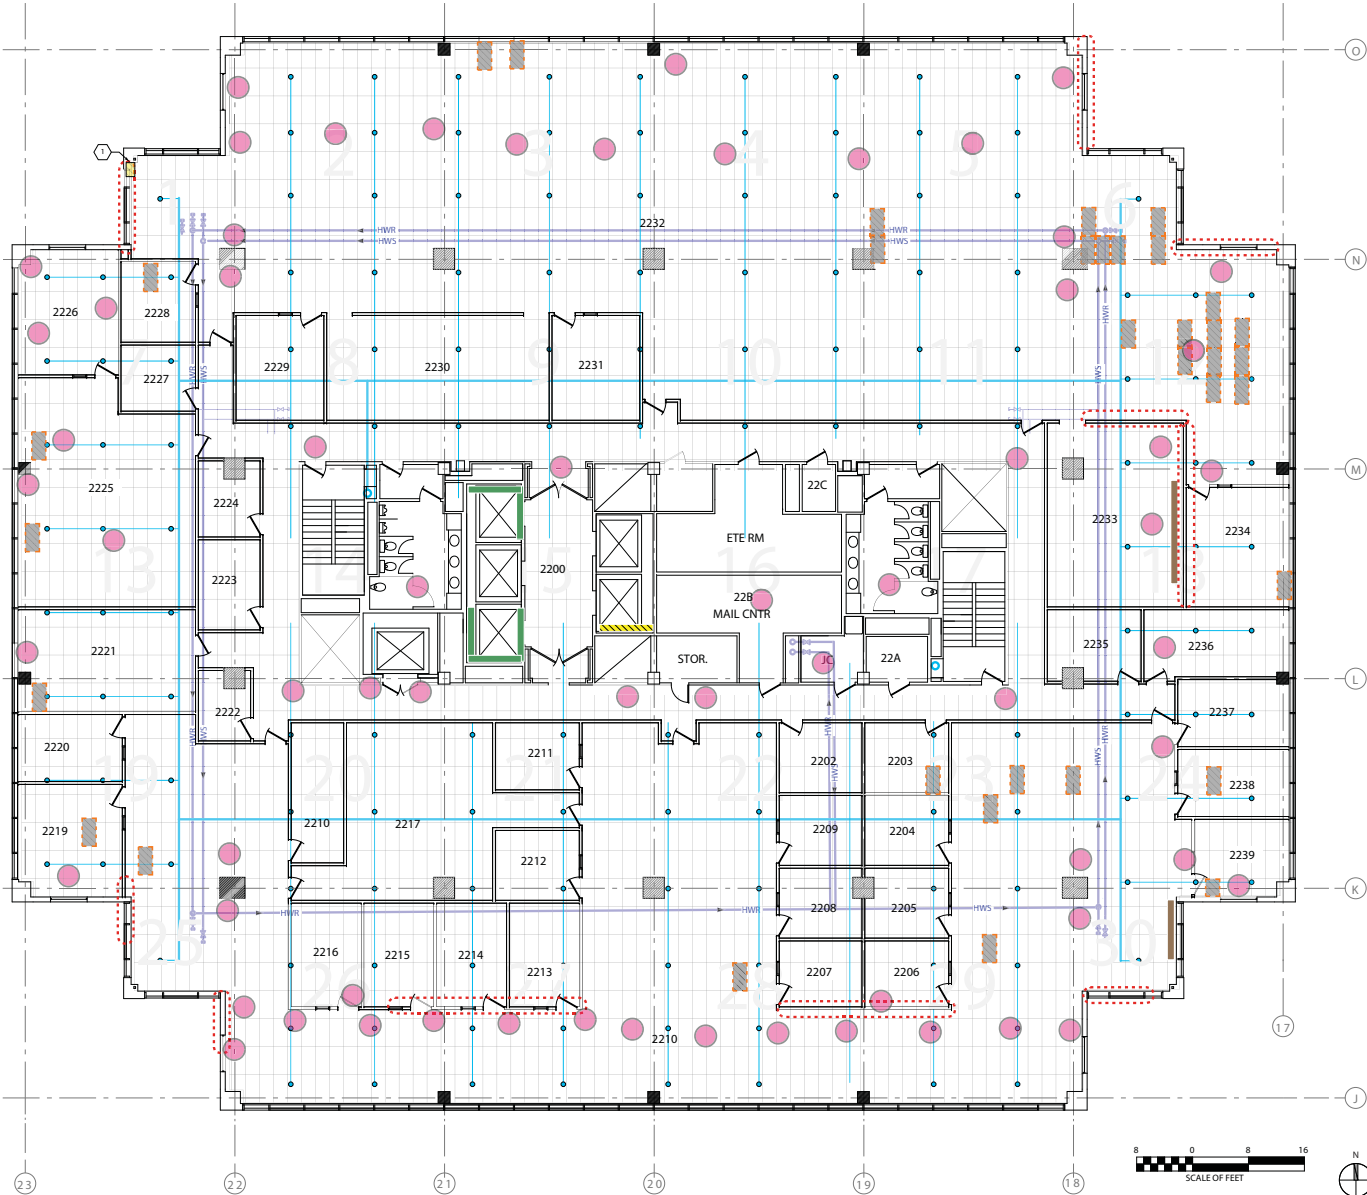
- ① Water stain on gypsum board in window corner

- Active water leak (remediated)
- Current water stained surface (remediated)
- Historical water leak/stained surface (remediated)
- Current mold growth (remediated)
- Historical mold growth (remediated)
- Current water on floor (remediated)
- Historical water on floor (no longer present, based on historical records only)
- Destructive testing location (historical)
- 325 Room number
- Above ceiling inspection location

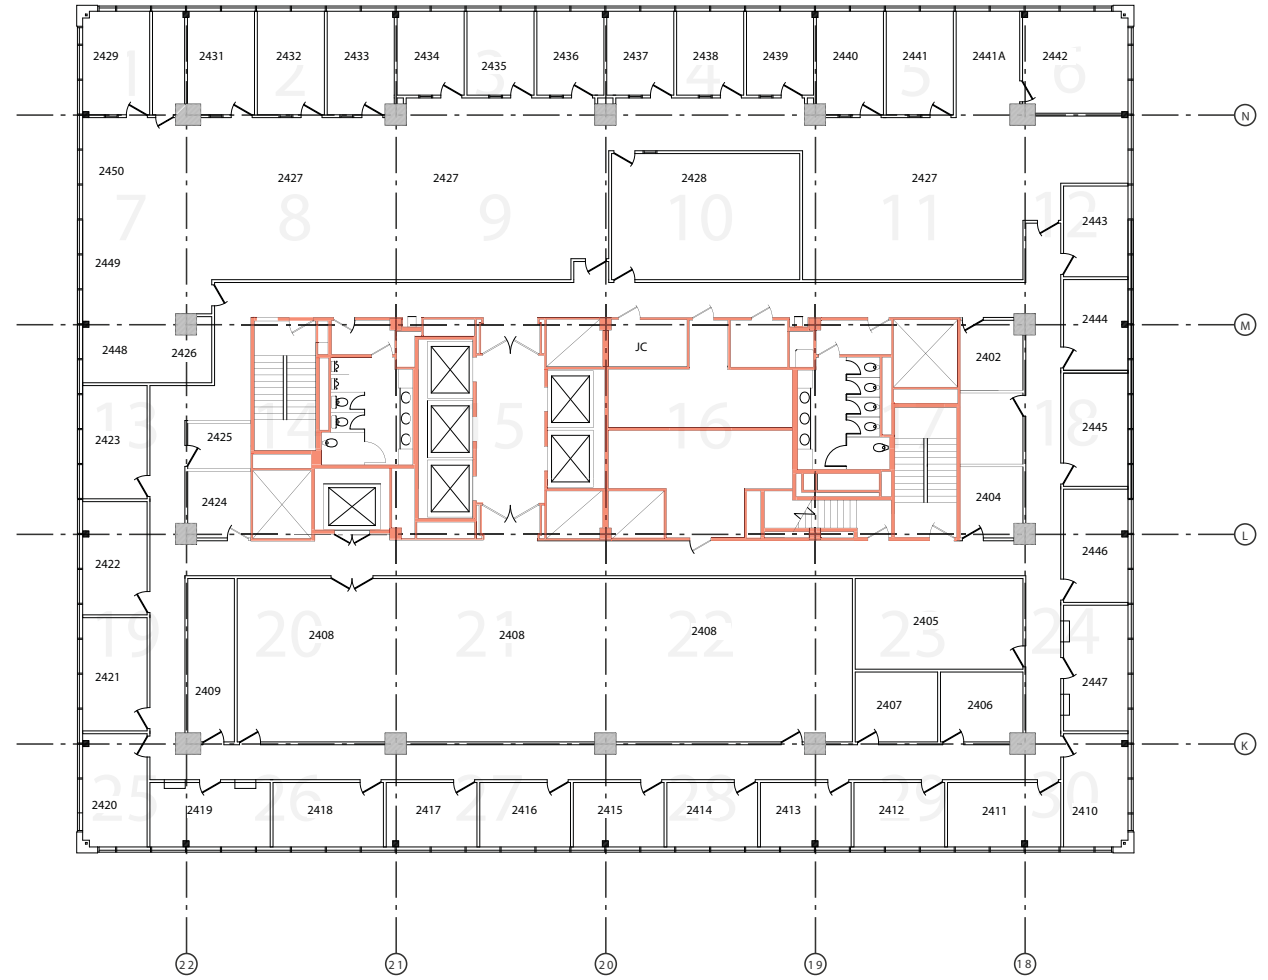
— Suspect mold location
